# James J. Peters VA Medical Center Chapel Façade Investigation and Probe

Solicitation No. 36C24223R0057

A/E Services by Mimar JM Murphy Architects & Engineers, LLC  
and specialty SME consultant Restoration Engineering Inc.

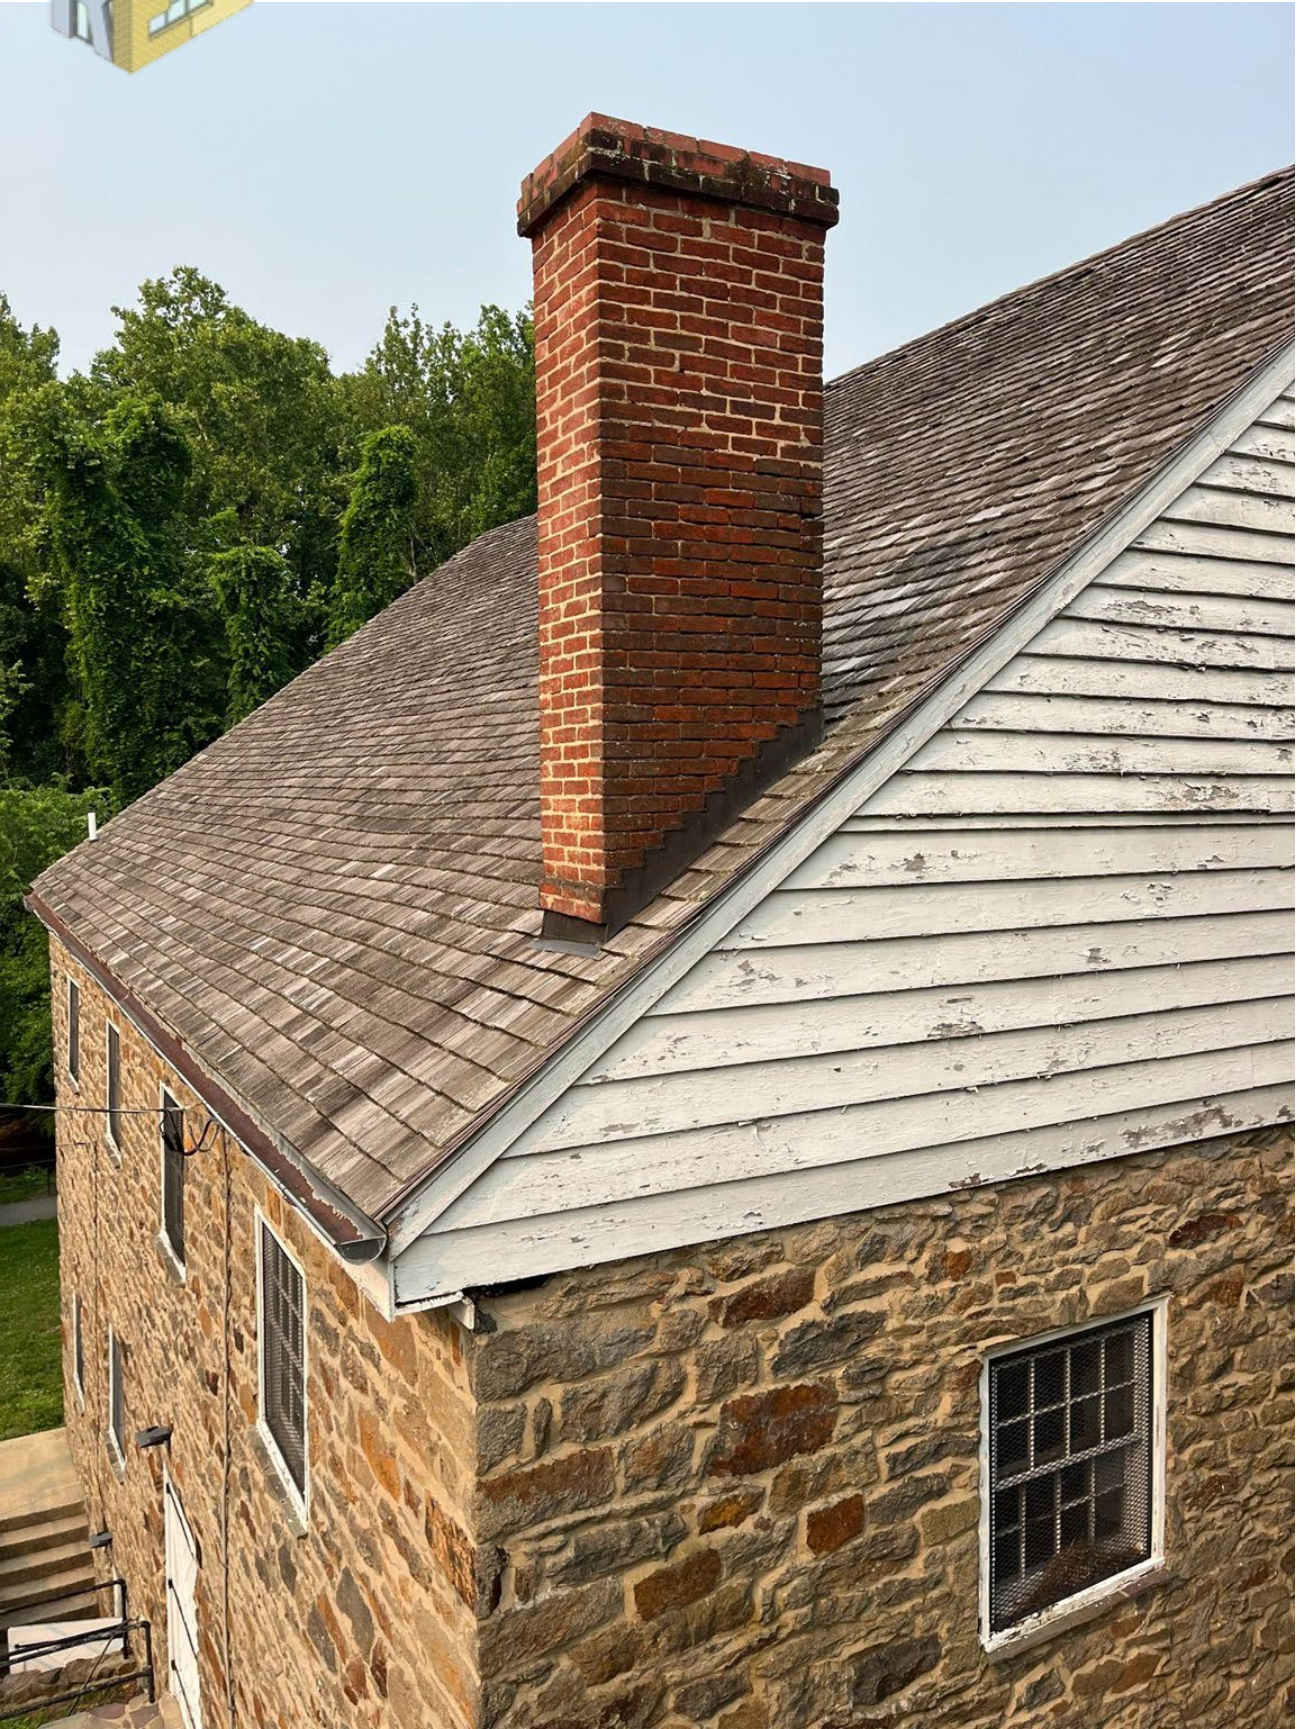
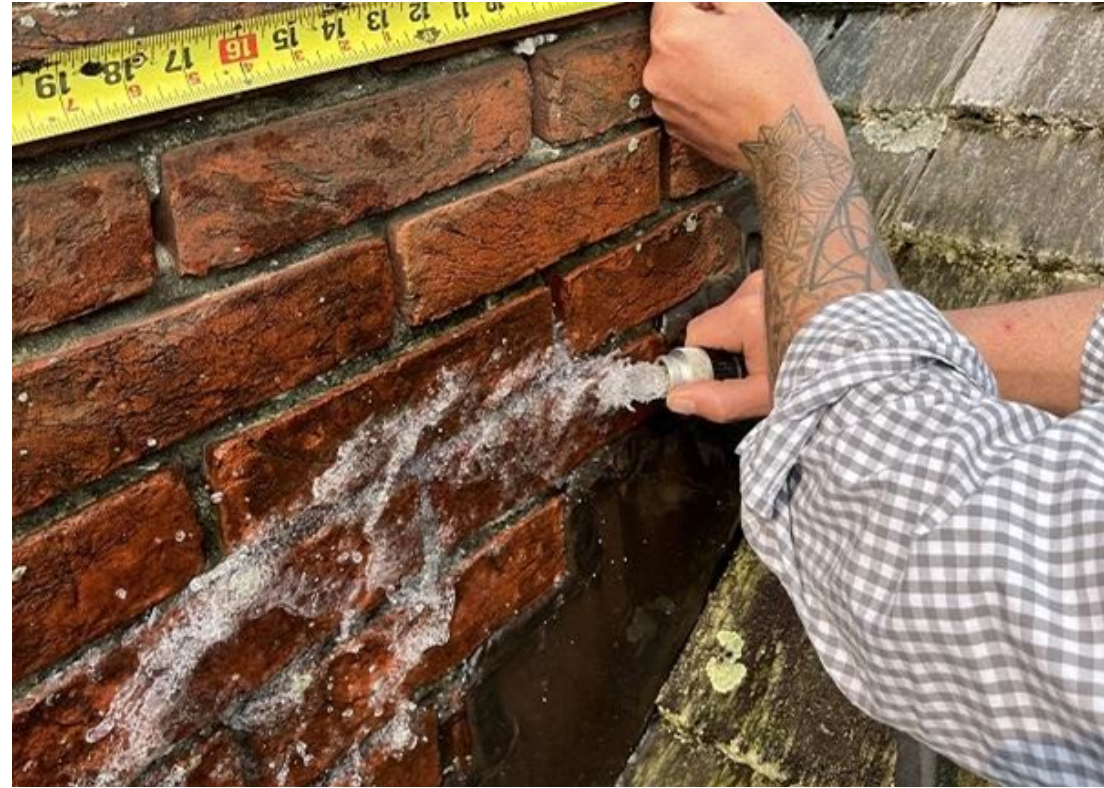
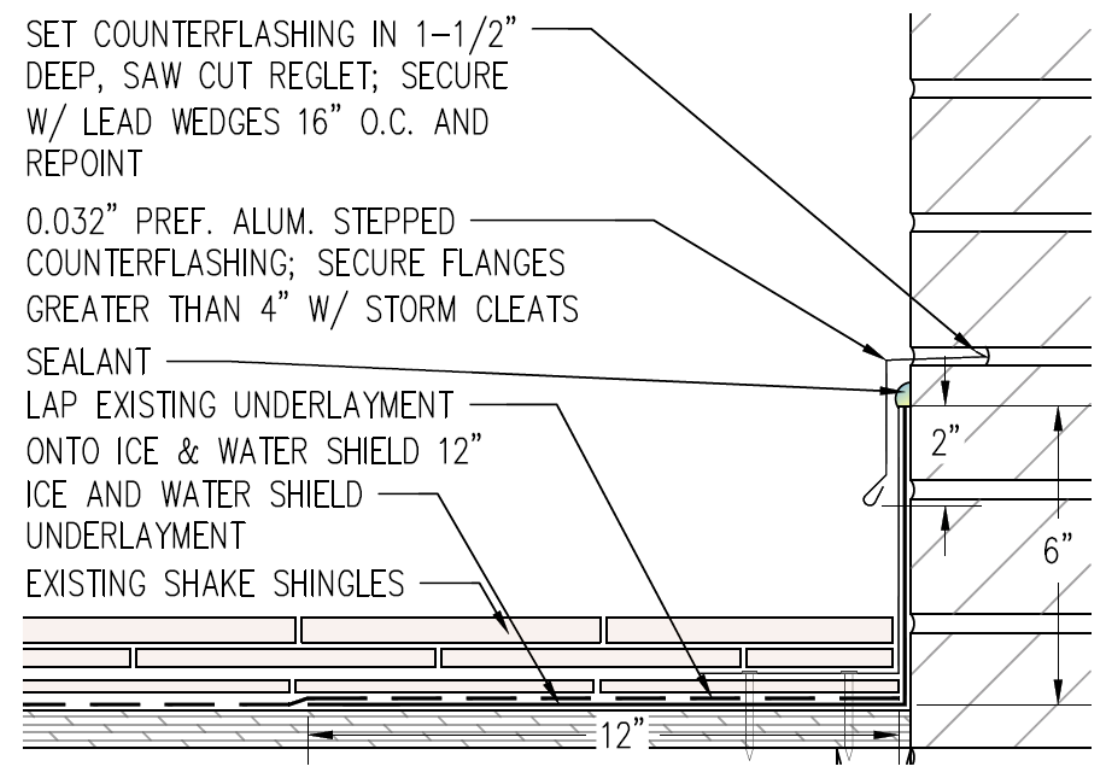
3 CHIMNEY STEP FLASHING DETAIL  
A-5.1 3" = 1'-0"

#### Chimney Masonry and Leak Repair

- The mill is currently experiencing leaks at the chimney.
- Performed an extensive investigation of the existing waterproofing system including water testing at the chimney.
- Prepared specifications to repoint the chimney with historically correct lime based mortar.
- Prepared designs for new chimney flashings, including copper base flashings, counterflashings, and a chimney cap flashing.

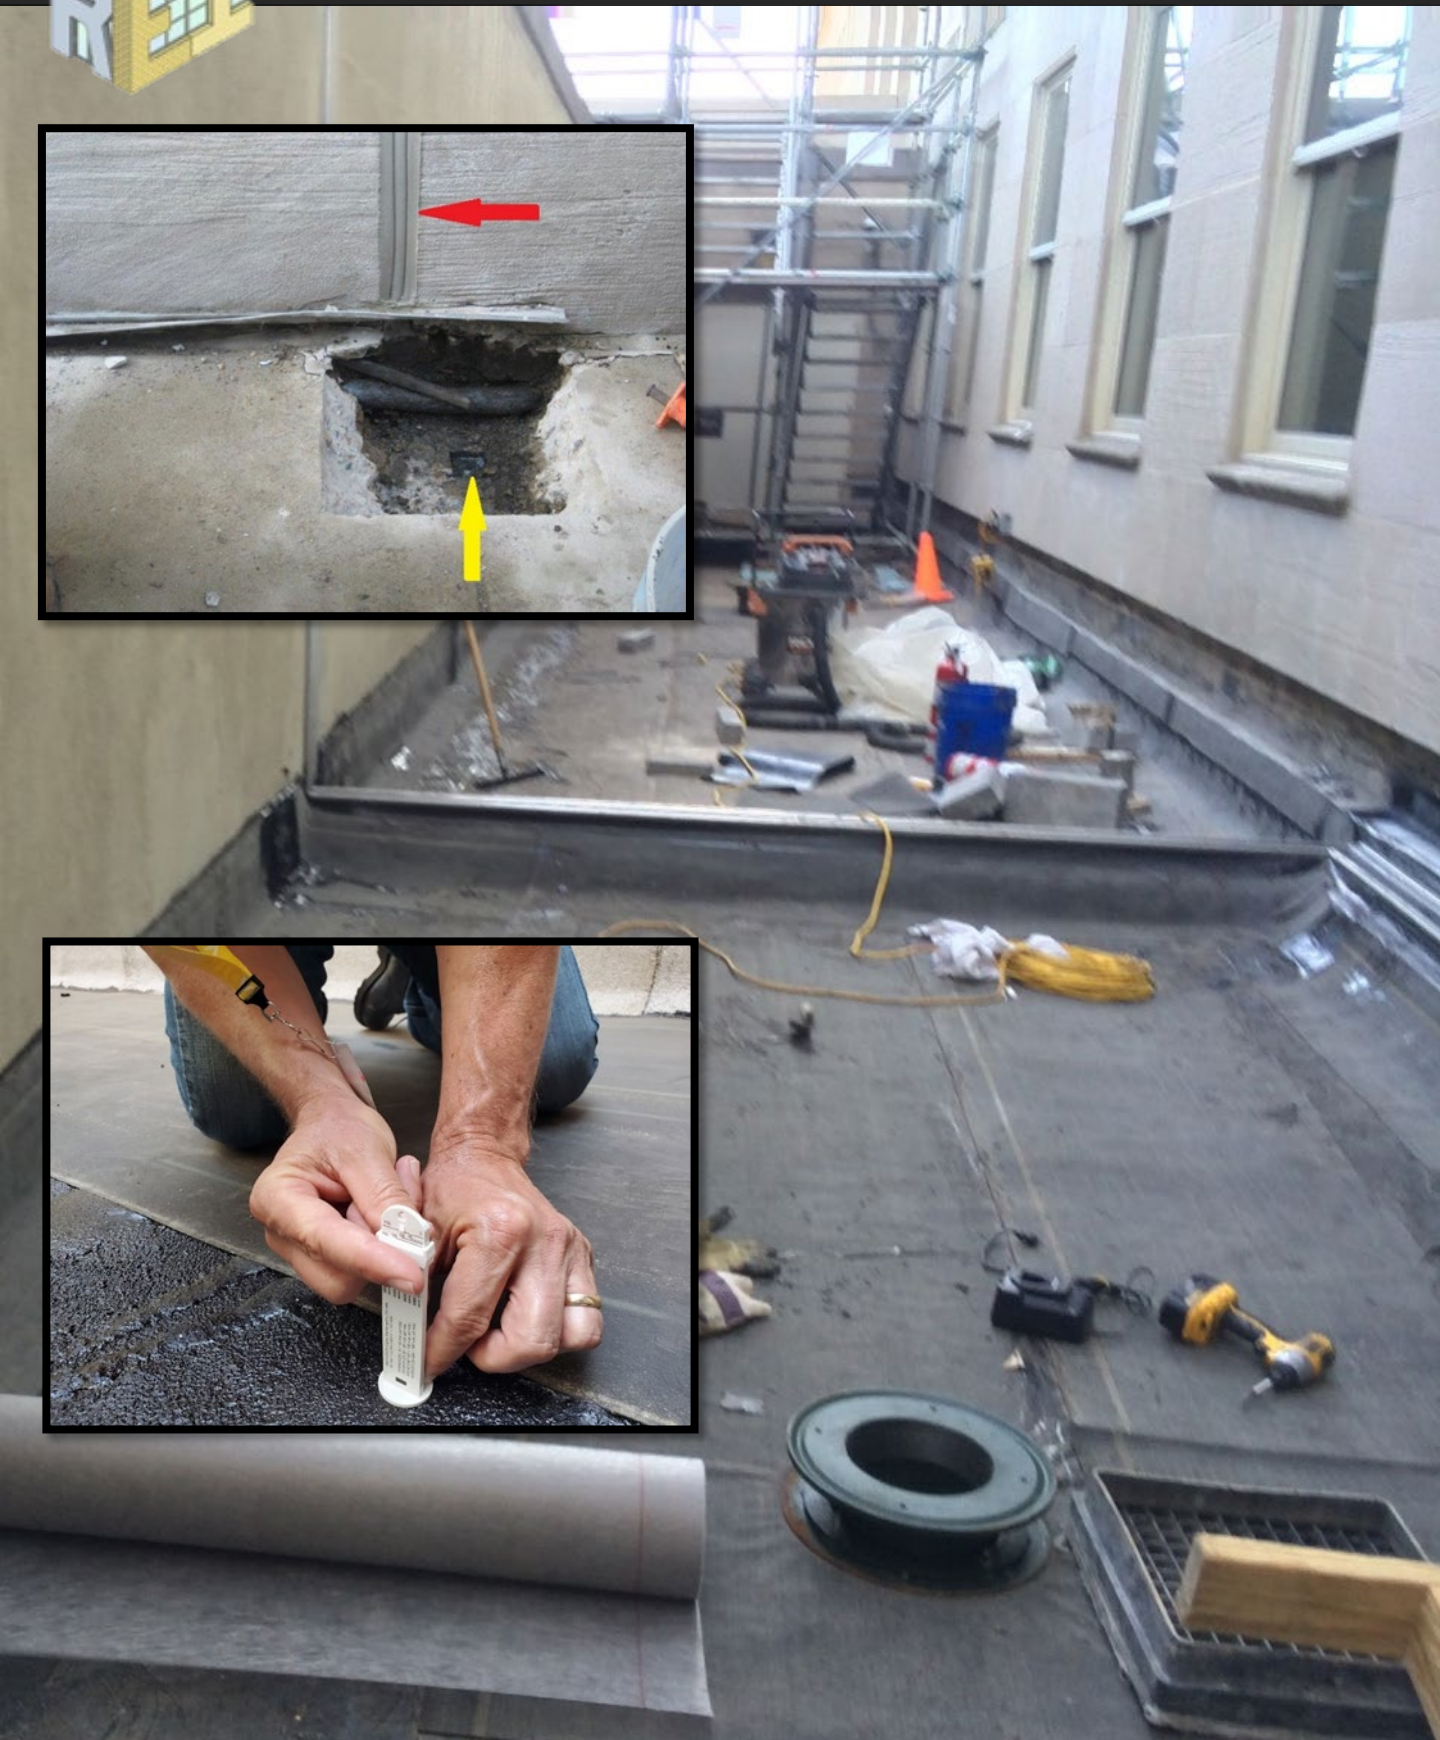
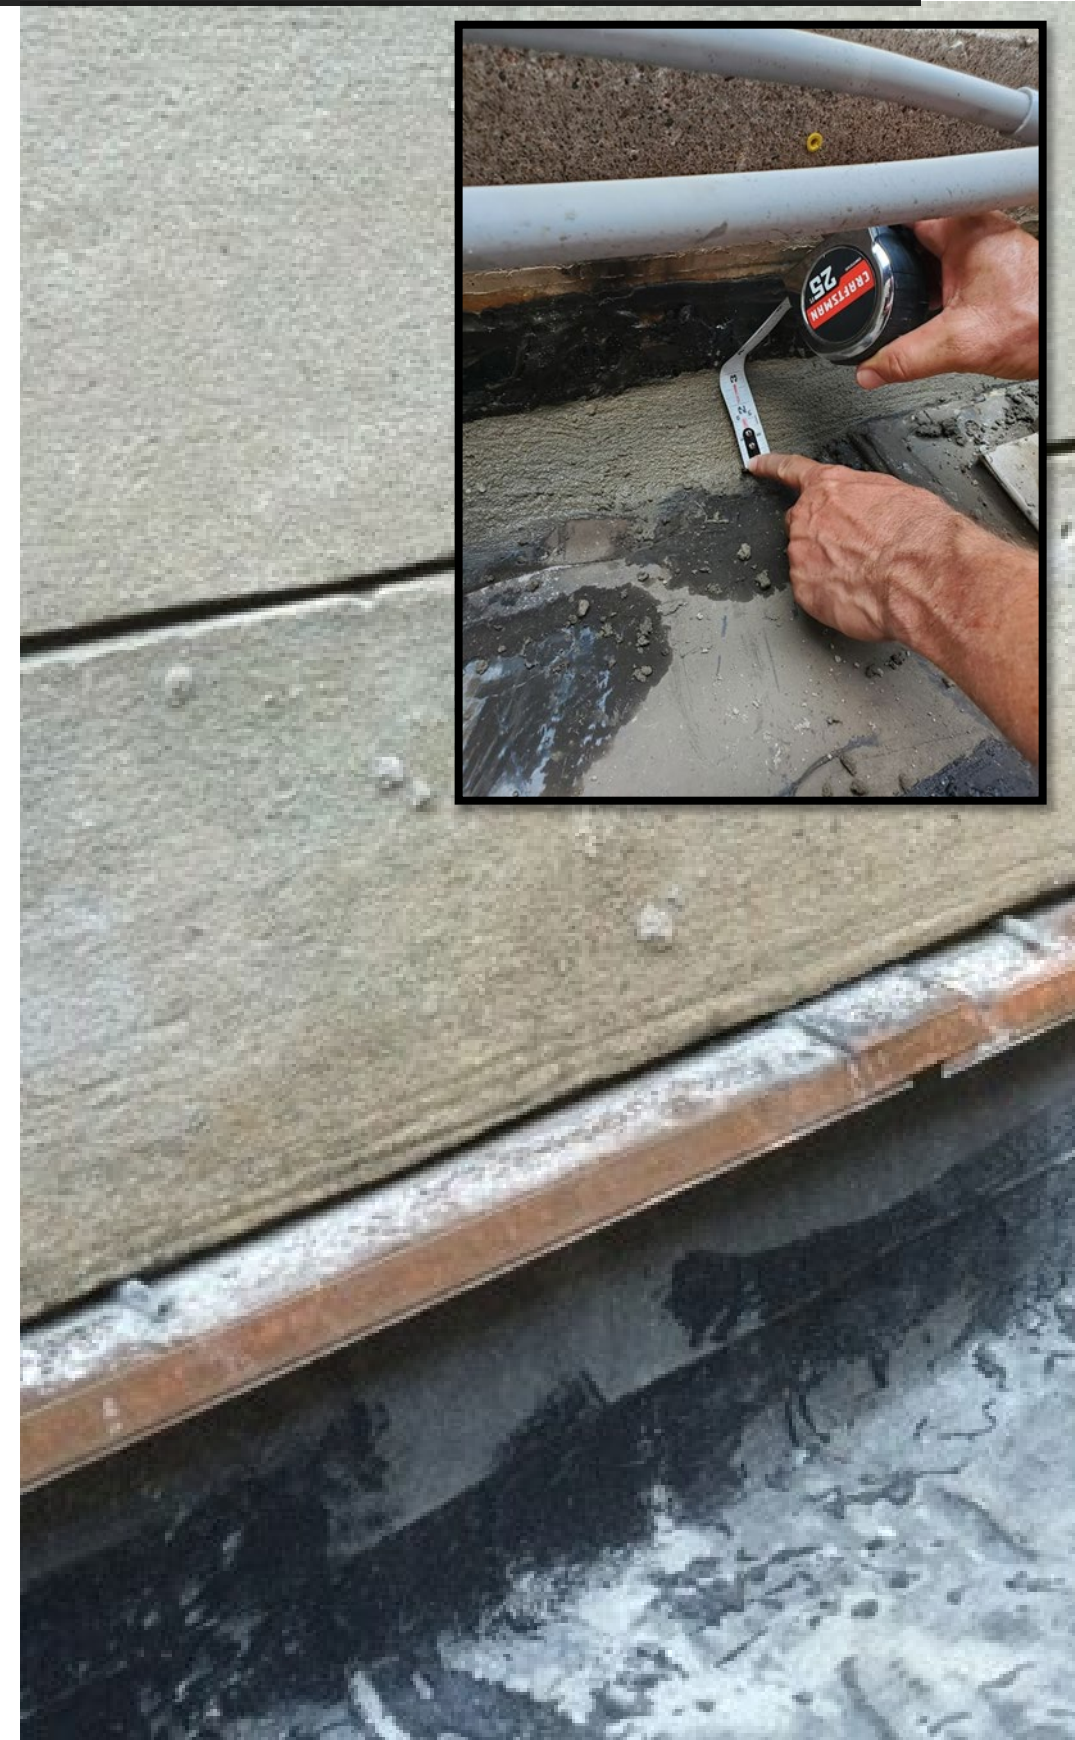
Pentagon RSAC Interstitial Space, Arlington, VA

- Performed investigation.
- Prepared a report identifying existing conditions and outlined a basis of design for repairs.
- Prepared drawings and technical specifications for waterproofing replacement including new hot-applied rubberized asphalt waterproofing system in the Mall Terrace moat.
- Project included removal and reinstallation of limestone wall panels to install new through-wall flashing
- Performed Contract Administration Services during construction.

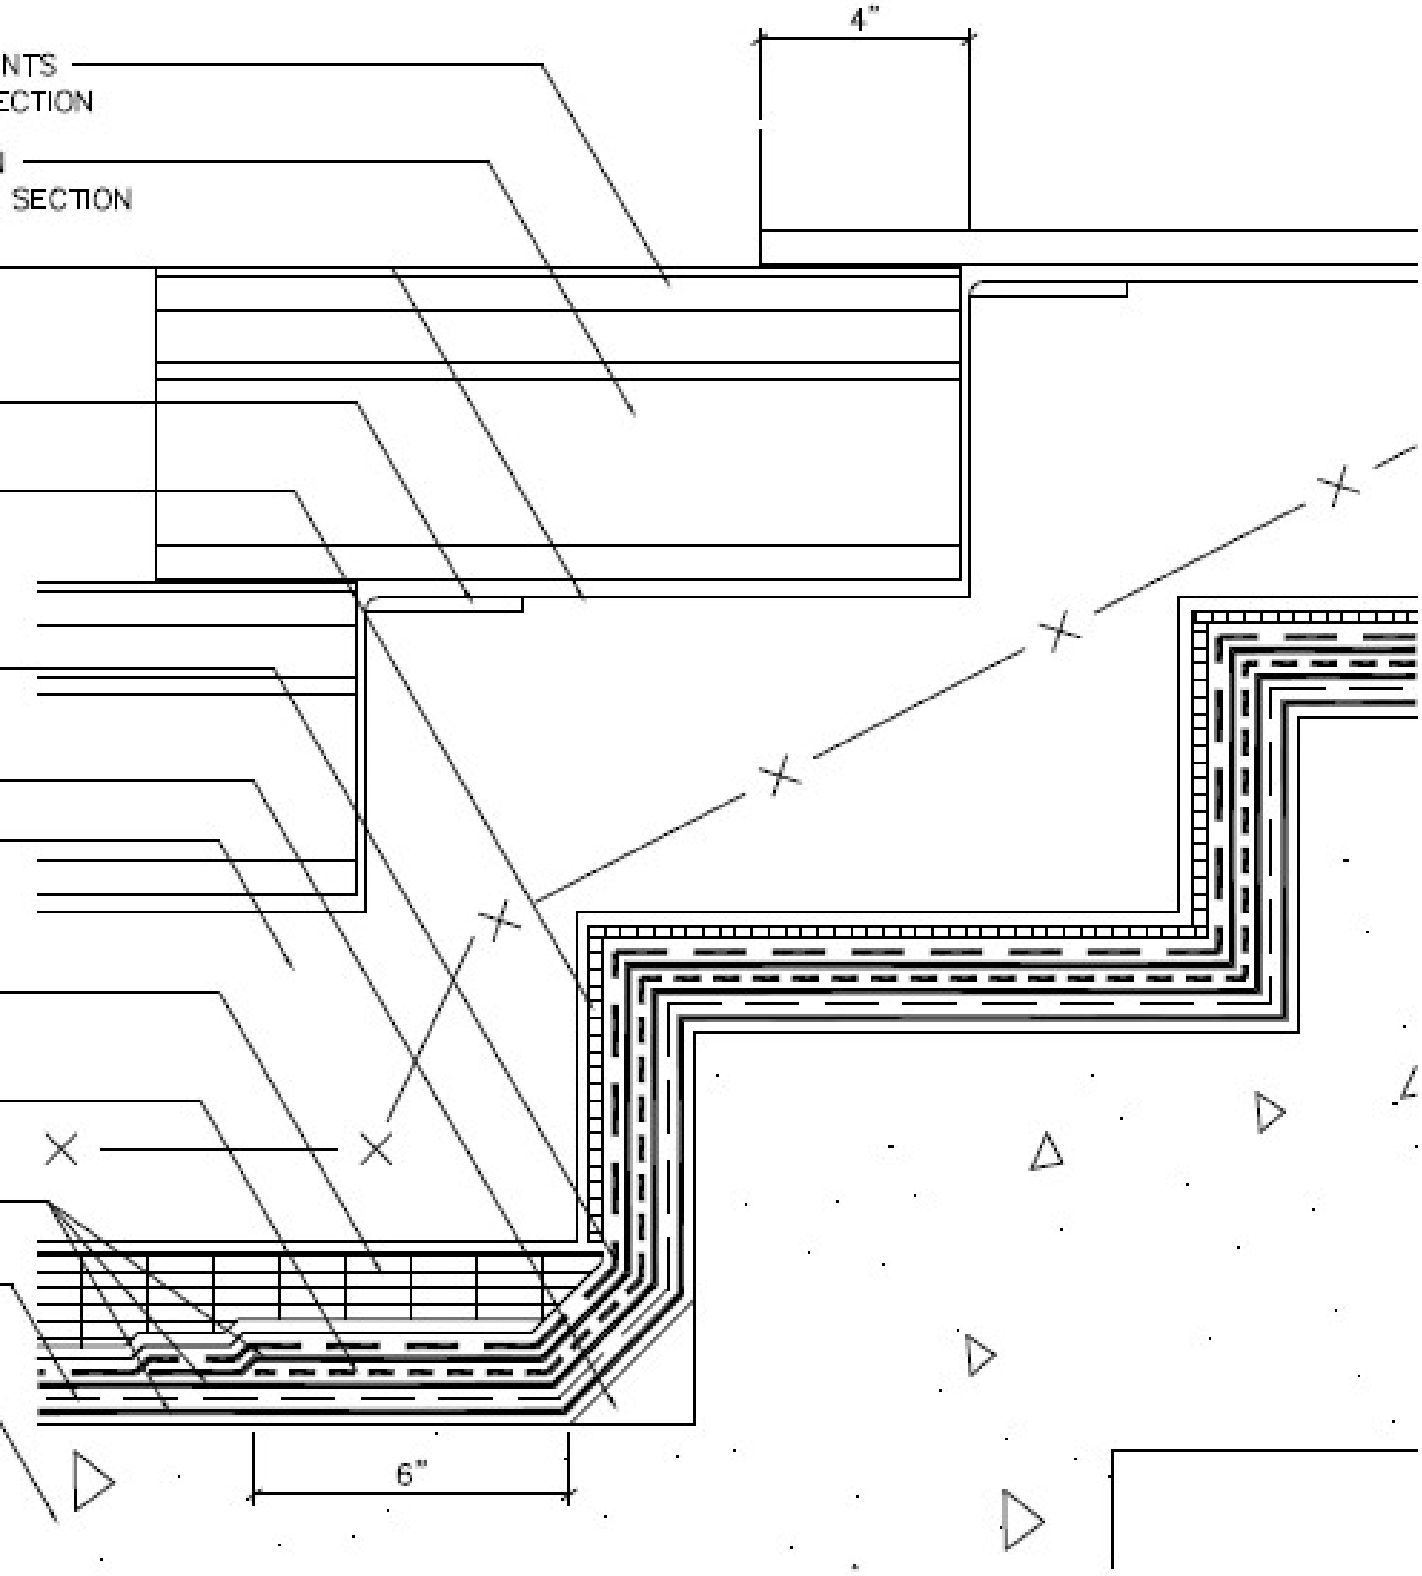
STAIRS AT MOAT FLOOR DETAIL 11

- 20 OZ COPPER RECEIVER; SOLDER ALL JOINTS WATERTIGHT; FASTEN W/NAILINS, 2 PER SECTION
- 20 OZ COPPER COUNTERFLASHING; FASTEN W/SCREWS W/NEOPRENE WASHERS, 2 PER SECTION
- REMOVE AND REPLACE CONCRETE TOPPING AT STAIRS TO INSTALL NEW WATERPROOFING; REINFORCE W/WWF
- CAST NEW STEEL STAIR NOSINGS INTO EDGE OF NEW CONCRETE TOPPING
- 6" WIDE STRIP OF DRAINAGE BOARD CONT. FROM TOP OF STEPS TO MOAT FLOOR; SPACE STRIPS 24" O.C. ACROSS STEPS

- SEPARATOR/PROTECTION SHEET SET IN HOT-APPLIED RUBBERIZED ASPHALT
- CONCRETE CANT
- REMOVE AND REPLACE CONCRETE TOPPING AT MOAT FLOOR TO INSTALL NEW WATERPROOFING; REINFORCE W/WWF
- 2" EXTRUDED POLYSTYRENE INSULATION BOARD W/BOTTOM DRAINAGE CHANNELS
- UNCURED NEOPRENE SHEET SET IN HOT-APPLIED RUBBERIZED ASPHALT
- HOT-APPLIED RUBBERIZED ASPHALT MEMBRANE
- POLYESTER SHEET
- EXISTING STRUCTURAL CONCRETE DECK

**IMPORTANT NOTE:** PITCH STAIR TREADS SLIGHTLY TO ENSURE NO PONDING WATER ON STAIRS.

**NOTE:** BASEFLASHING BEYOND EXTENDS TO UNDERSIDE OF LIMESTONE COPING AT SOUTH SIDE OF STAIRS AND 4" ABOVE TOPPING (STEPPED AS SHOWN ON THIS DETAIL) AT NORTH SIDE.

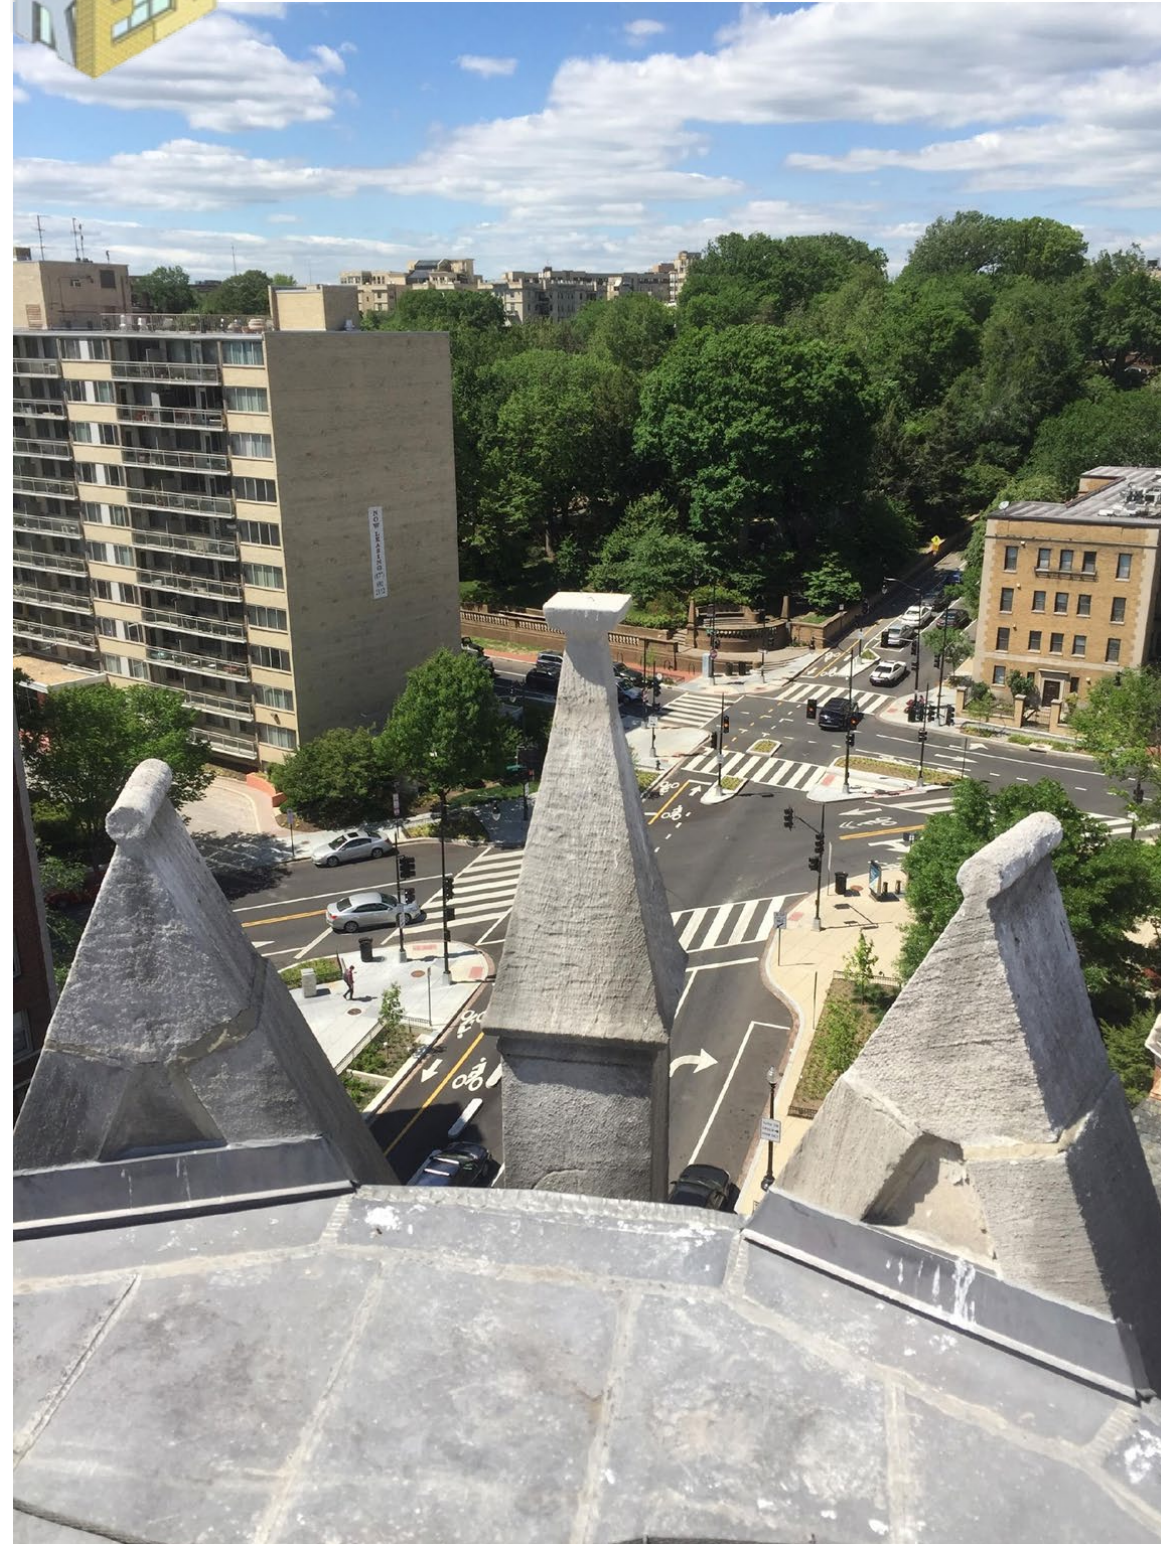
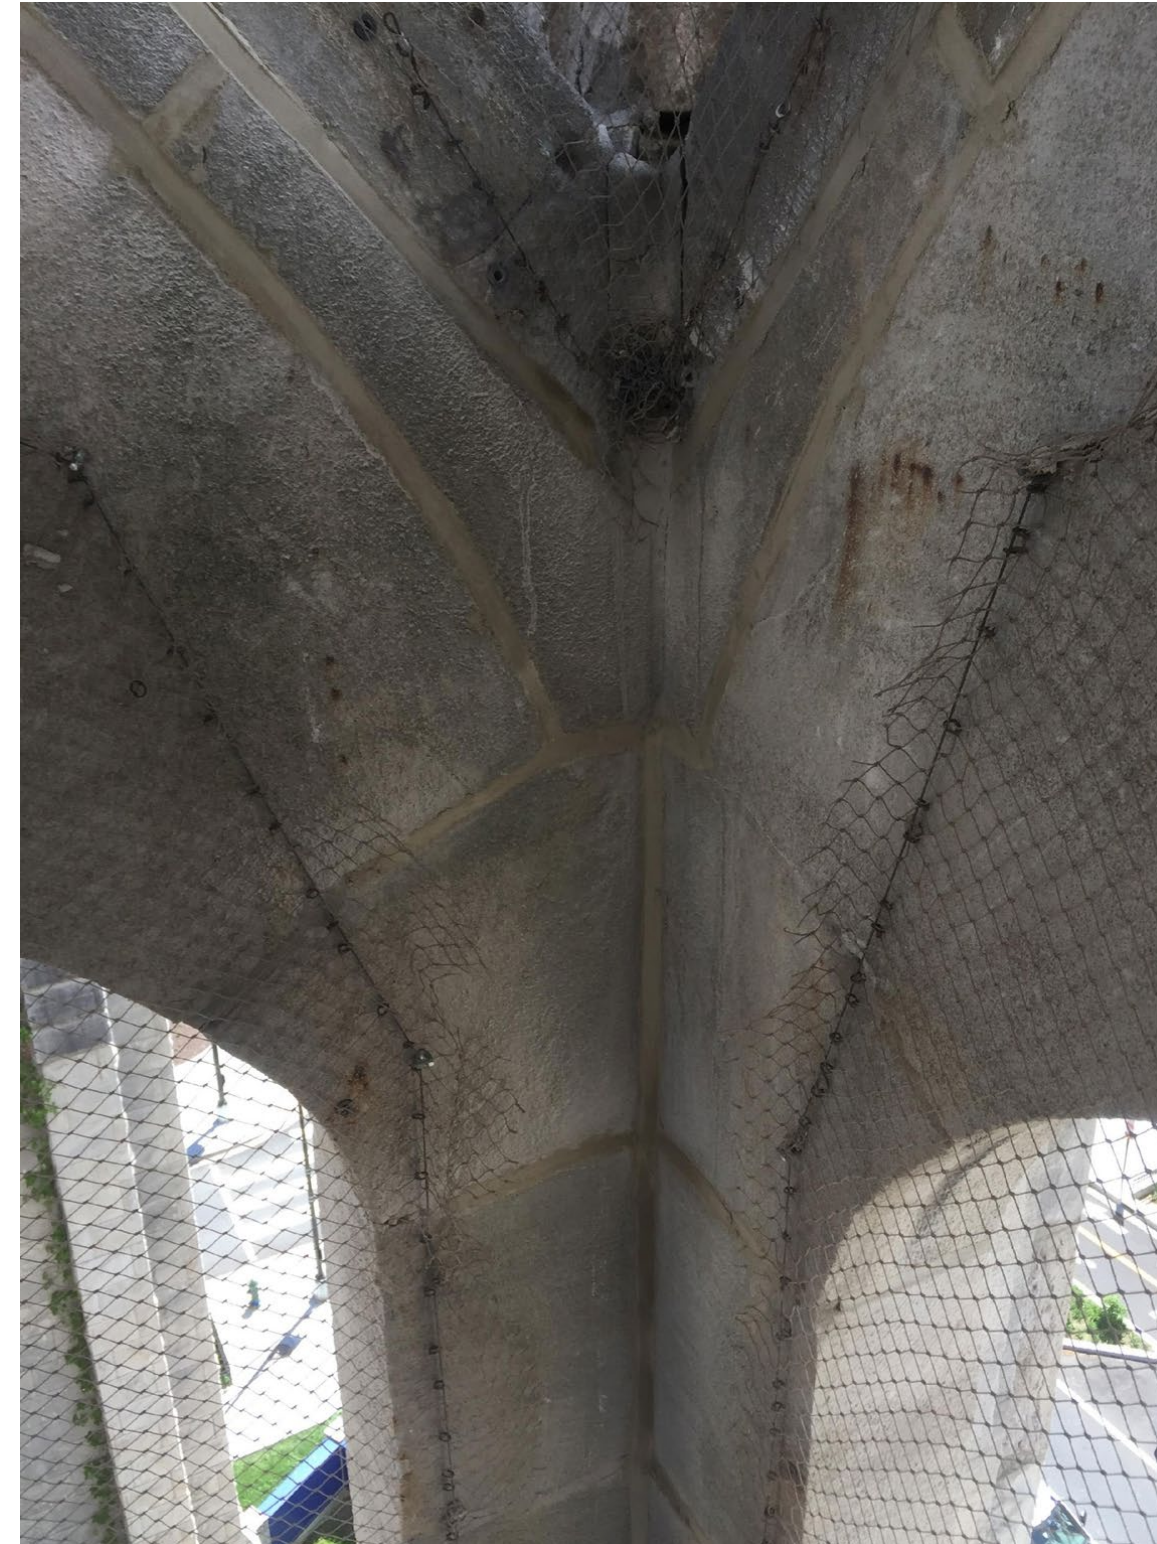
- The steeple was experiencing deterioration of the reinforced concrete, brick and stone masonry, and wood framing, due to prolonged moisture intrusion.
- Performed an extensive investigation of the existing steeple to identify extent of deterioration and water damage.
- Prepared specifications to repoint the stone mortar joints and reform steeple finials with specialty restoration mortar.
- Prepared designs for stone and brick masonry repointing and stitching repairs, reinforced concrete repairs, and traffic coatings.

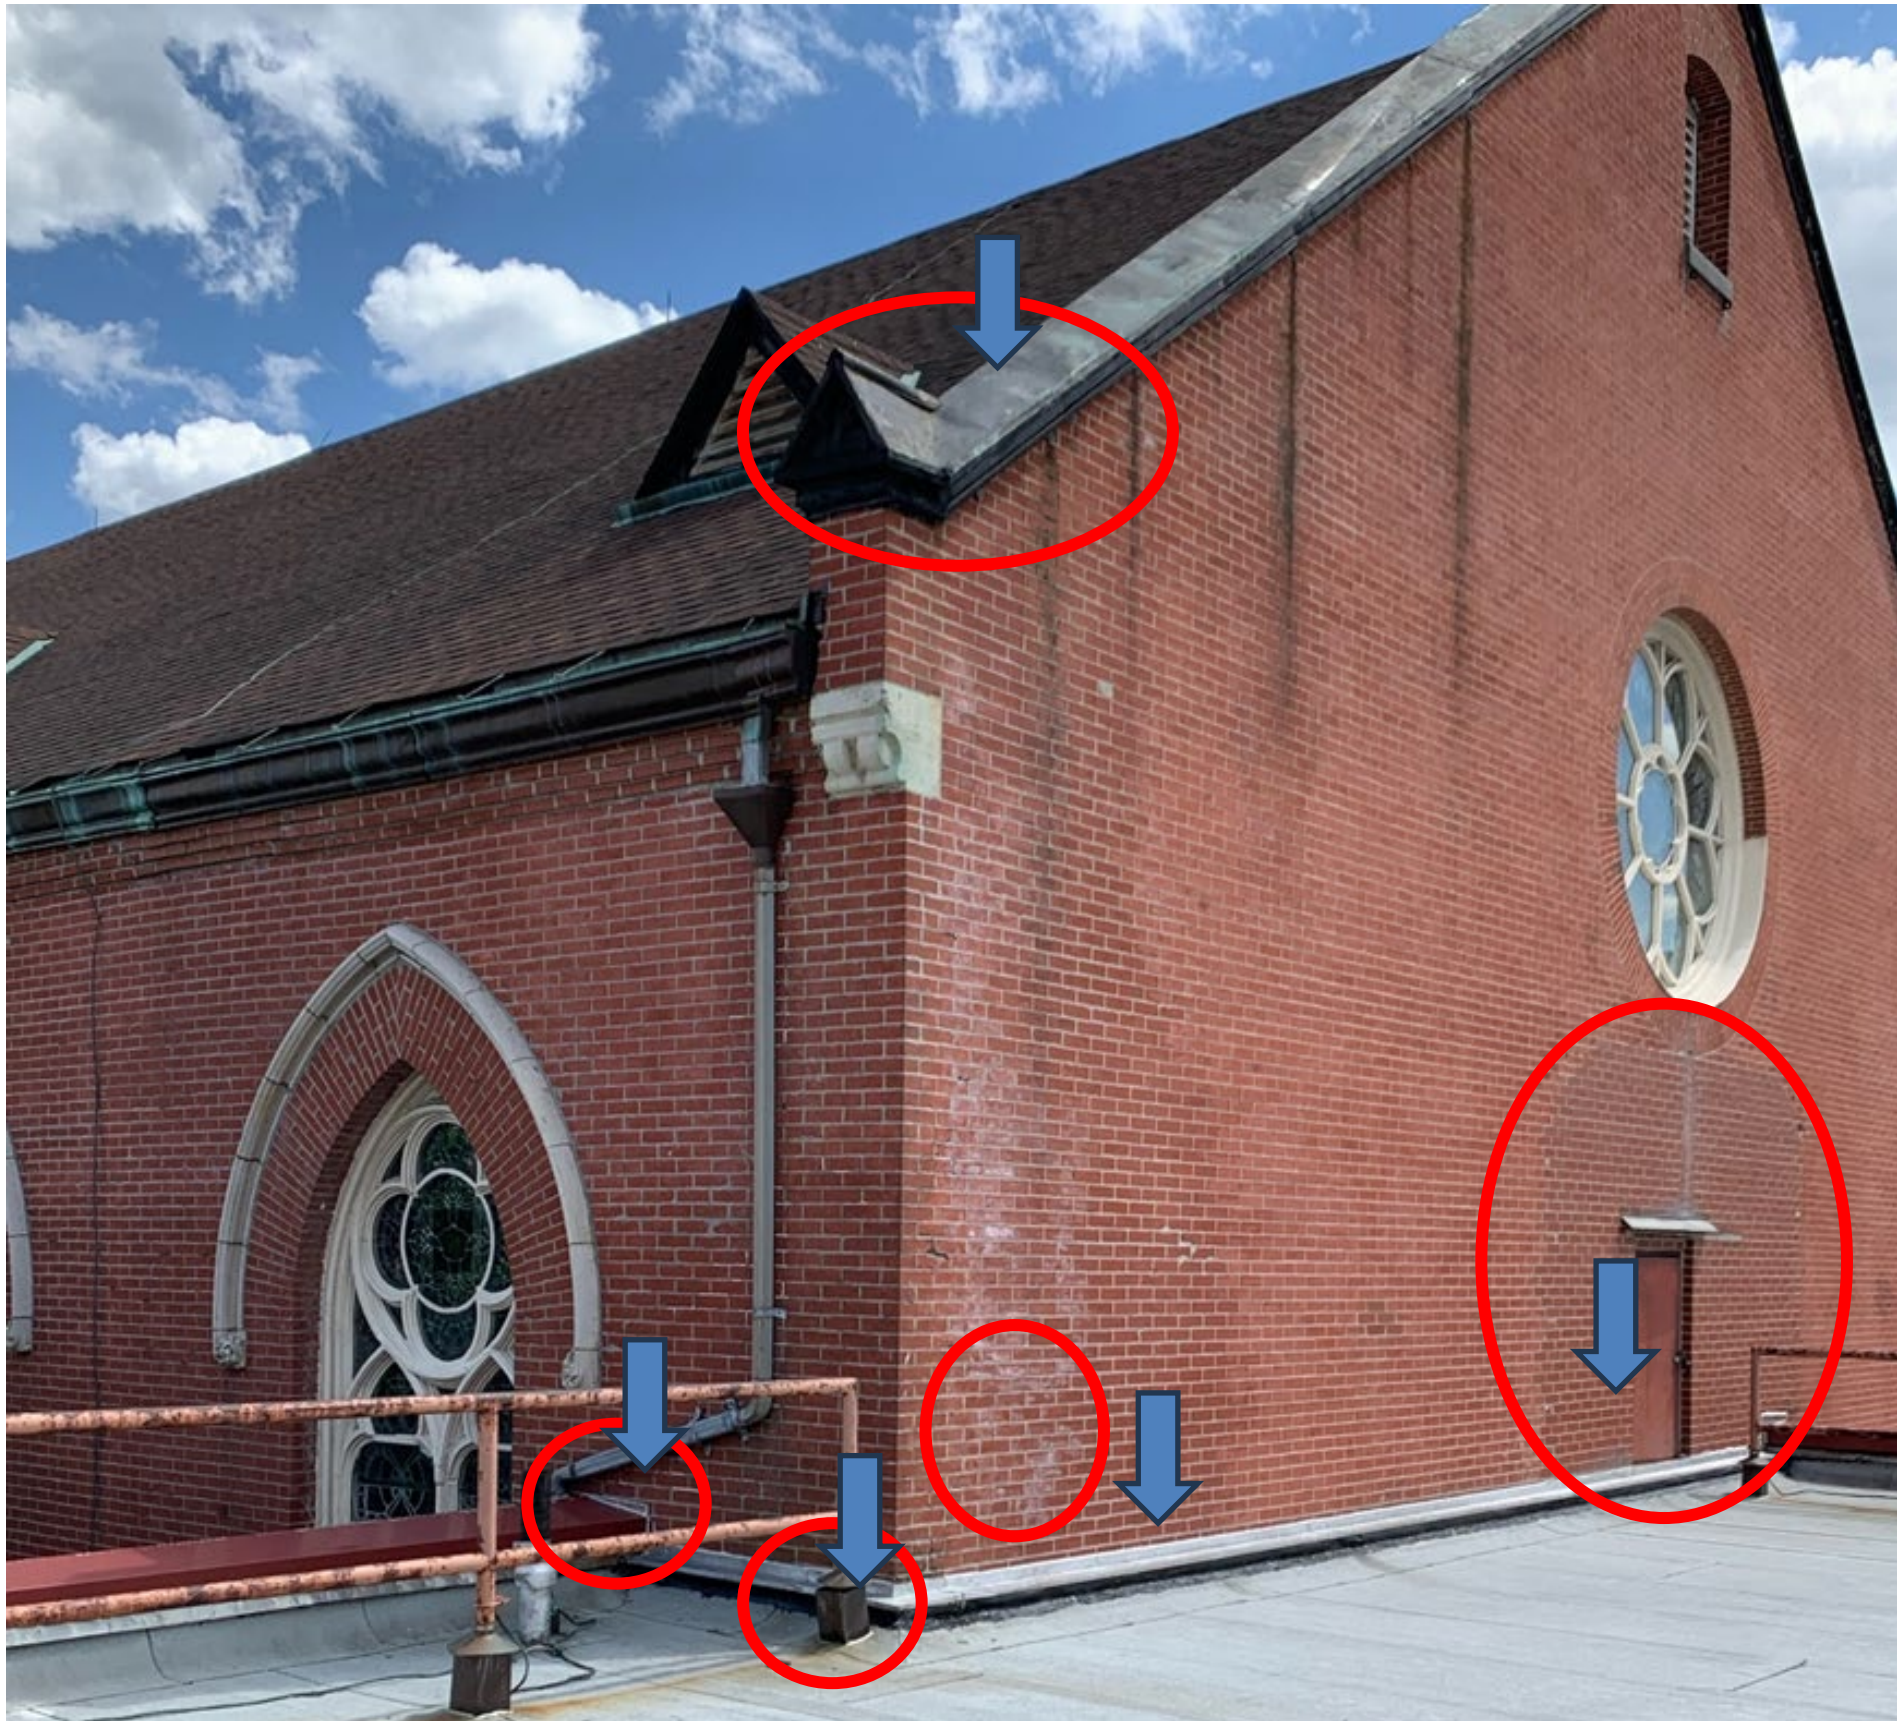
Discuss w/Building Personnel and observe location where leaks show inside the building

Visually inspect:

- the gable end wall coping and base flashings (not visible in photo)
- the masonry mortar joints and brick units themselves
- Flat roof membrane, base flashing, expansion joint flashing, counterflashing and railing post flashings
- Parapet coping end dam
- Window, door opening

Infra red moisture survey masonry wall /flat roofing

Test cut (Probe):

- Gable end wall coping
- Gable end wall roof/base flashing
- Brick masonry above counterflashing
- Flat roof membrane
- Interior wall location
- Interior ceiling location

Water test

- Flat roofing/Railing penetrations
- Base flashings
- Counterflashings
- Coping tie-in to masonry wall
- Door flashings
- Brick masonry (ASTM C 1601-08)
- Brick masonry Rilem Tubes
- Round window
- Gable base flashings
- Gable copings

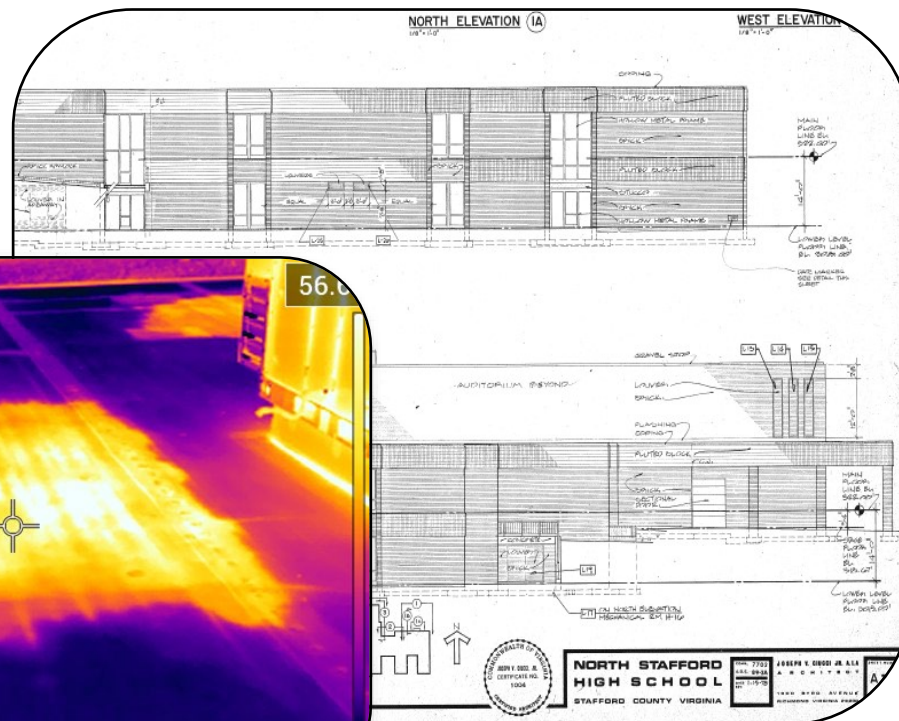
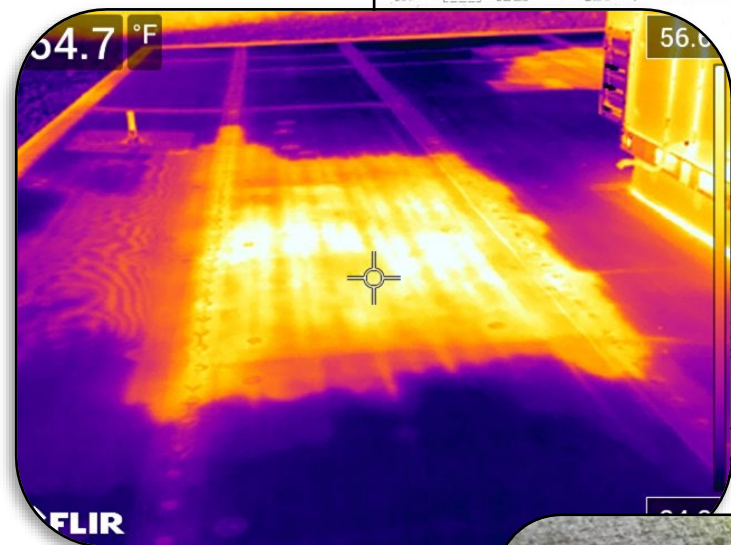
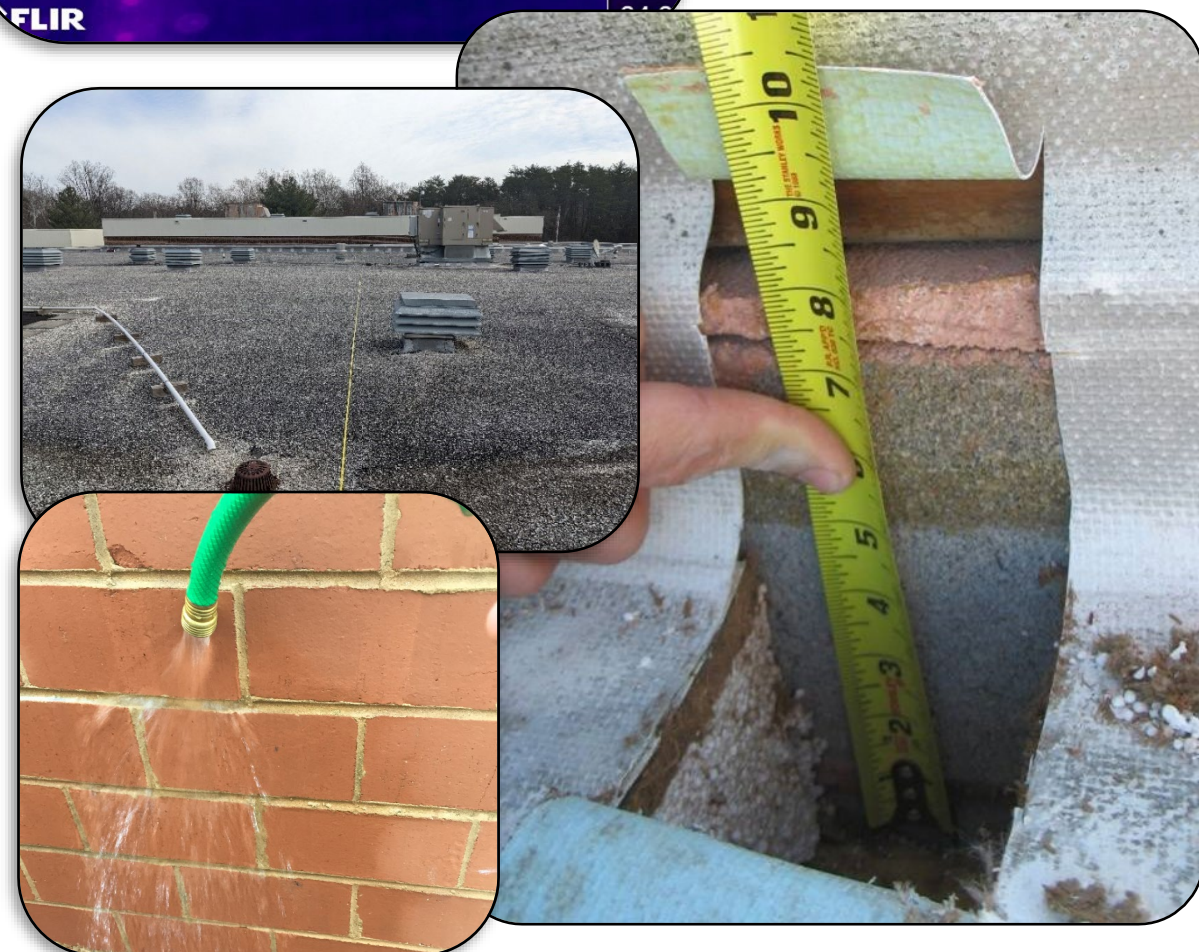
Acquire and Review available construction drawings.

Interview maintenance personnel for pertinent maintenance history and extent of unsatisfactory conditions.

Perform a detailed visual inspection of the existing roofing system.

Perform a non-destructive infrared moisture survey.

Observe investigative test cuts to understand existing construction.

Field measure existing building components to verify dimensions.

Perform water tests to identify sources of leaks.
